SLANTING DESIGN: A Pilot Program

FINAL REPORT

October 1985

by Alexander Shaw

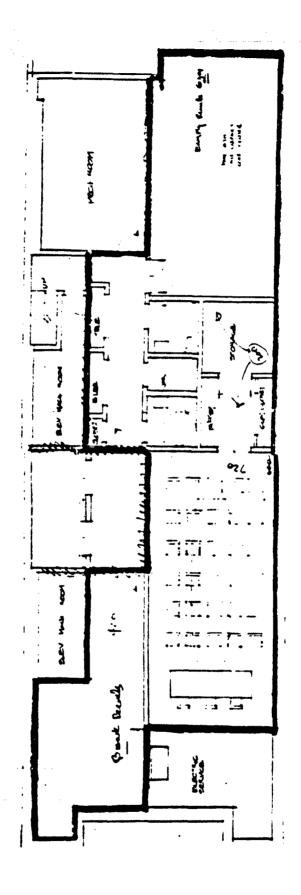
FIGURE 2 -- Preliminary Plan of Office Basement with Shelter

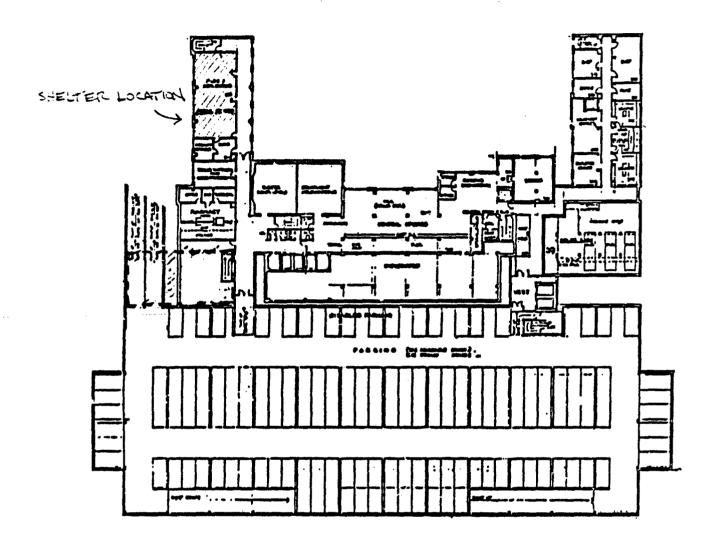
PRST BASENENT LEVEL FLOOR FLAN

FIGURE 4 -- Hospital Alternative #1 -- First Basement Plan

Design Alternatives. The original design concept involved placing the blast shelter in the medical records area of the existing hospital facility (see Figures 4). Questions arose when AIAF discovered that this section of the hospital was to be partially exposed above grade. Discussion with FEMA led to the determination that renovation type construction was not desired.

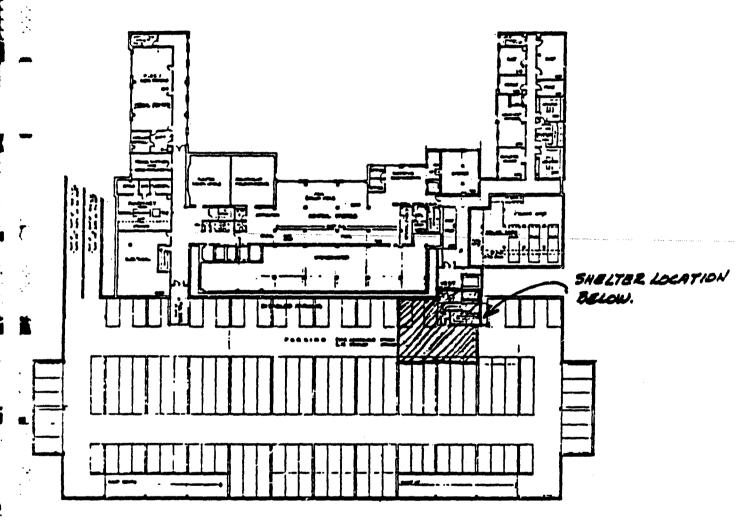
PRST BASENENT LEVEL FLOOR FLAN

FIGURE 7 -- Hospital Alternative =2 -- First Basement Plan

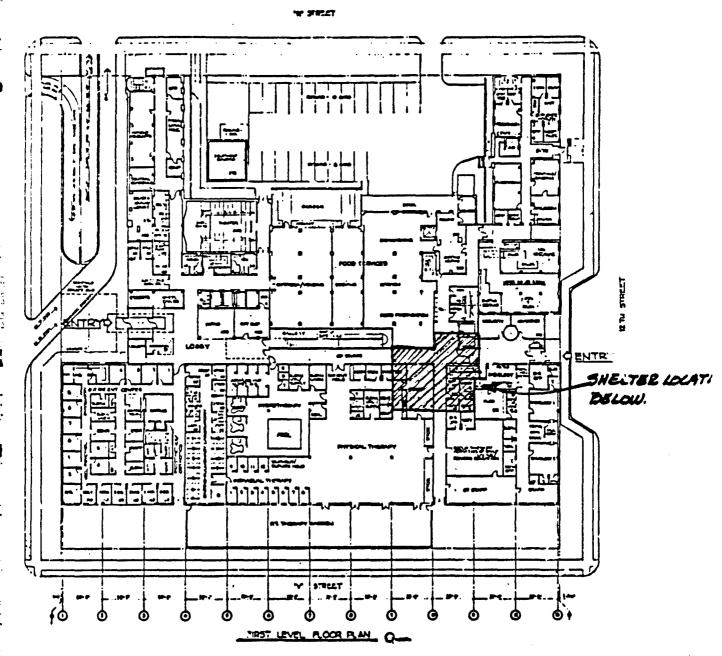
FIGURE 9 -- Hospital Alternative #3 -- First Floor Plan

Another location was considered and rejected (see Figure 9).

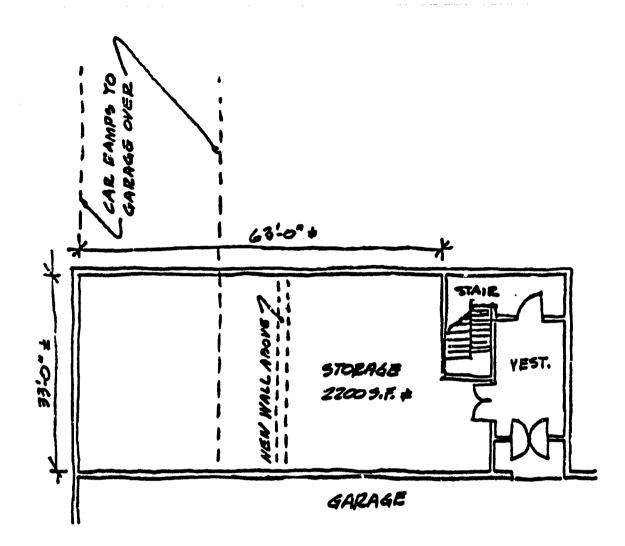
SECOND BASEMENT LEVEL PLAN 1/16:110 1/18/82
NPH SHELTER

FIGURE 10 -- Hospital Alternative #4 -- Shelter Plan

The last concept was placement of the blast shelter on the grade of the lowest parking level (see Figure 10-13). One potential problem with that location was that it fell immediately below the garage ramps. This location was selected and detailed design commenced in March of 1982.

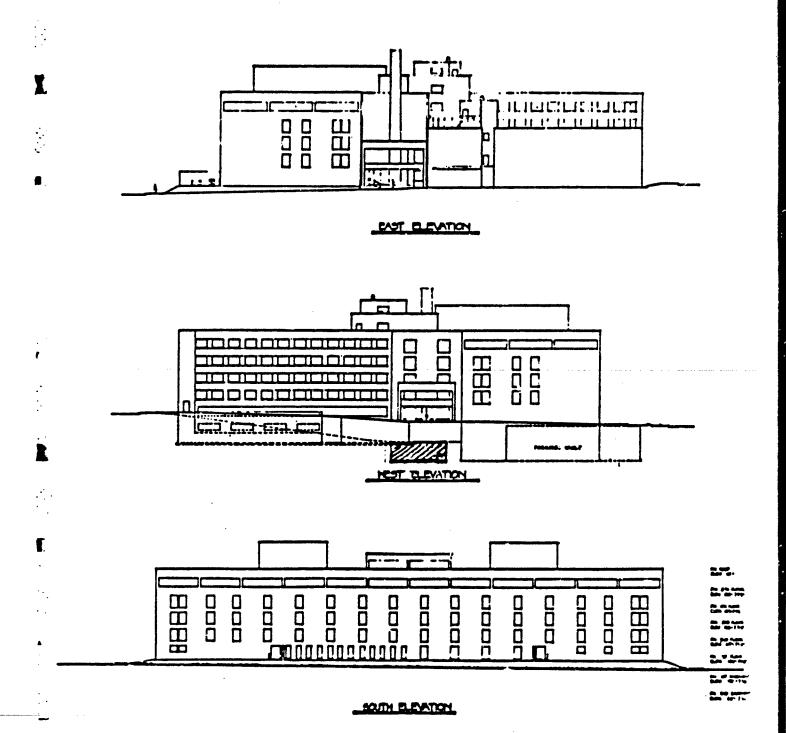
FIGURE 11 -- Hospital Alternative #4 -- Sections & Elevation

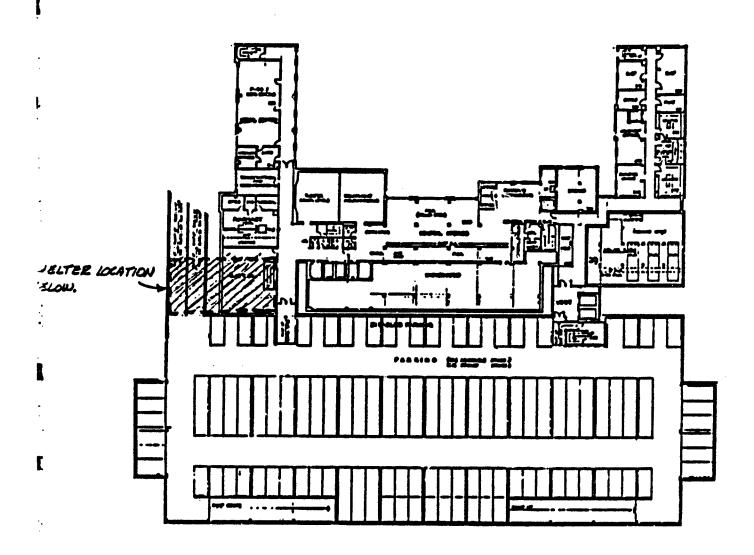
PRST BASDIENT LEVEL FLOOR FLAN

FIGURE 12 -- Hospital Alternative #4 -- First Basement Plan

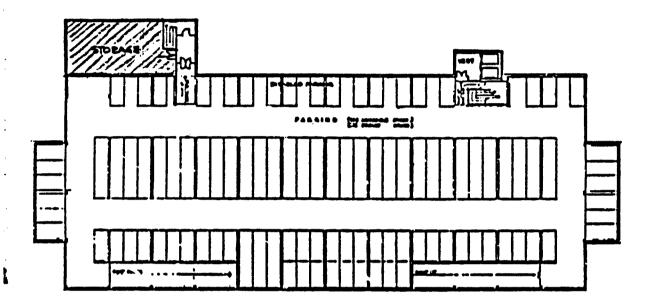
SHOULD BASEMENT LEVEL, MOOR PLAN 0.

FIGURE 13 -- Hospital Alternative #4 -- Second Basement Plan

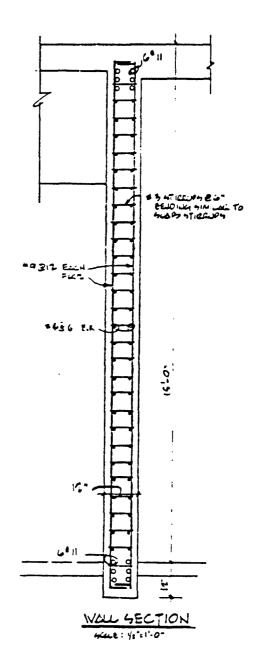
FIGURE 16 -- Structural Details -- Sections

By November of 1982 the shelter location was selected (see Figure 14), alternative designs were considered, and structural design calculations (see Figures 16-20) were completed. These preliminary calculations, by Don Neubauer, PE, are included as Appendix A of this report. A preliminary construction bid from Turner Construction Company was received at this time (see Figure 15).

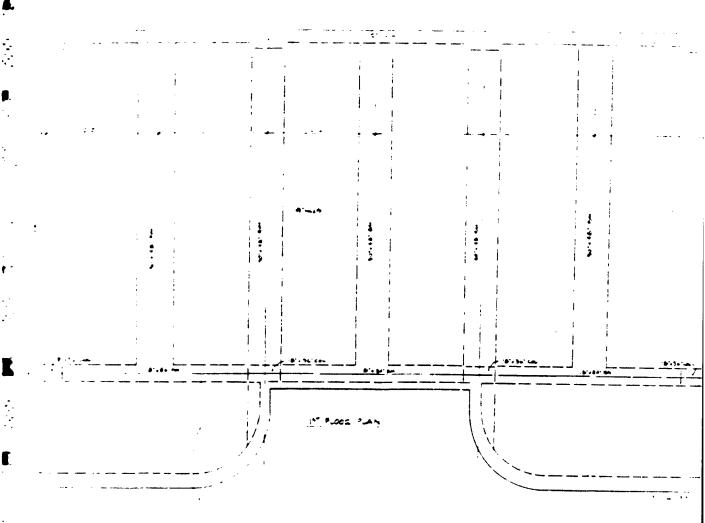
FIGURE 18 -- Structural Details -- First Floor Plan

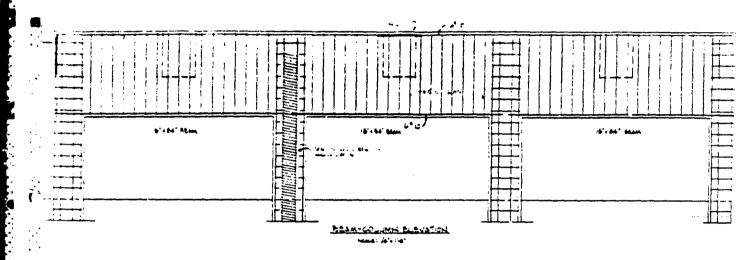
FIGURE 19 -- Structural Details -- Beam Details

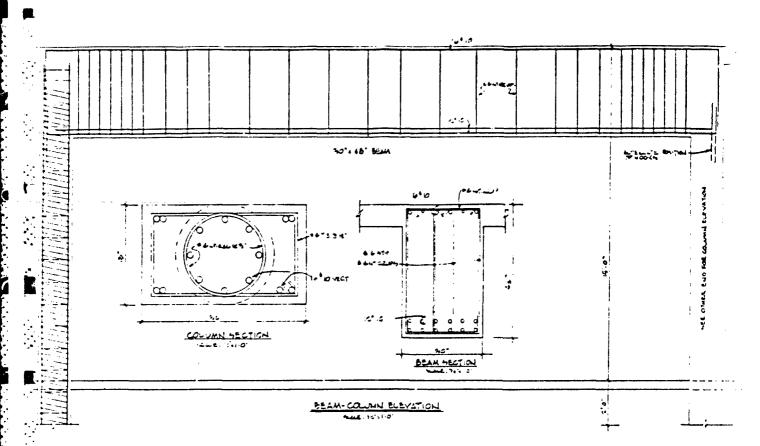
FIGURE 20 -- Structural Details -- Column Details

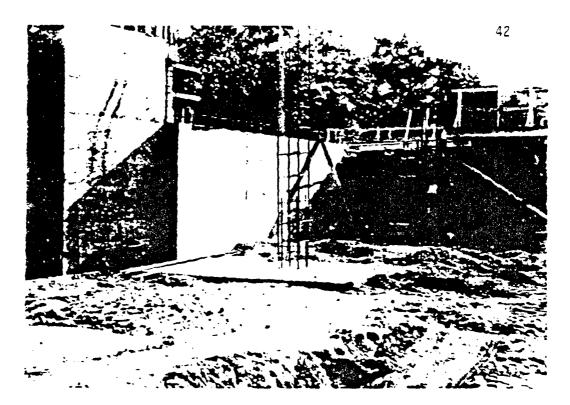
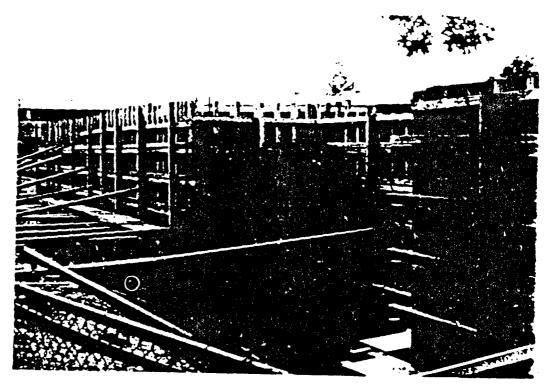
A: Interior

B: Exterior

FIGURE 25 -- Hospital Construction -- South Wall of Shelter

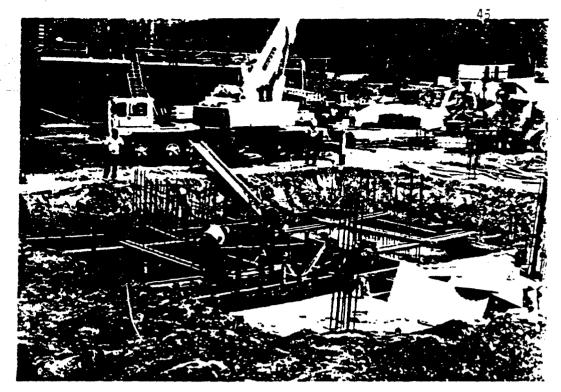
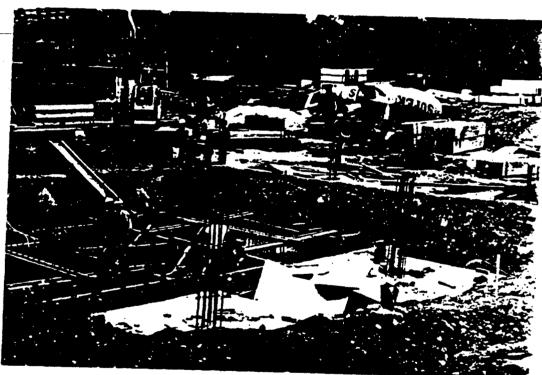
FIGURE 28 -- Hospital Construction -- Concrete Formwork

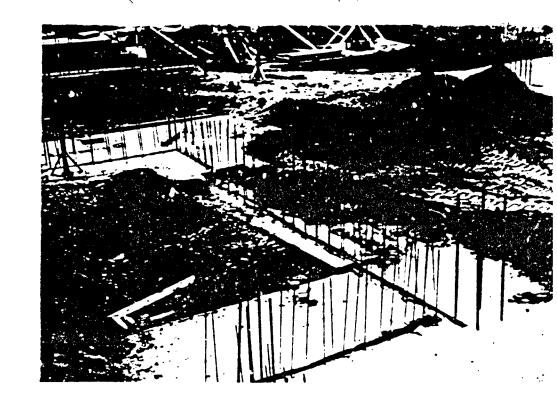
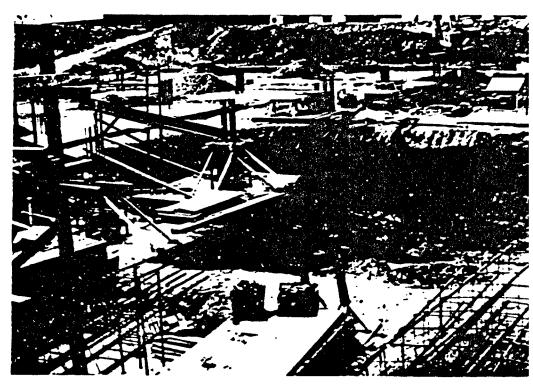
FIGURE 29 -- Hospital Construction -- Footing Poured

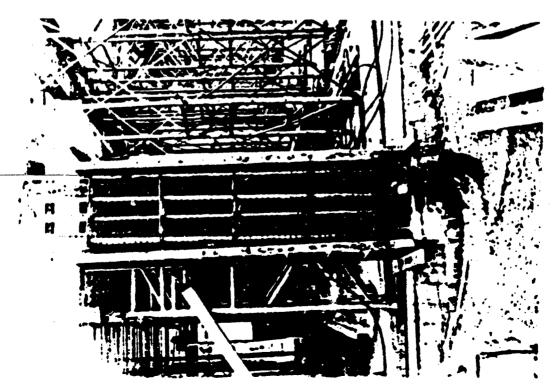
FIGURE 30 -- Hospital Construction -- Column Reinforcing Steel

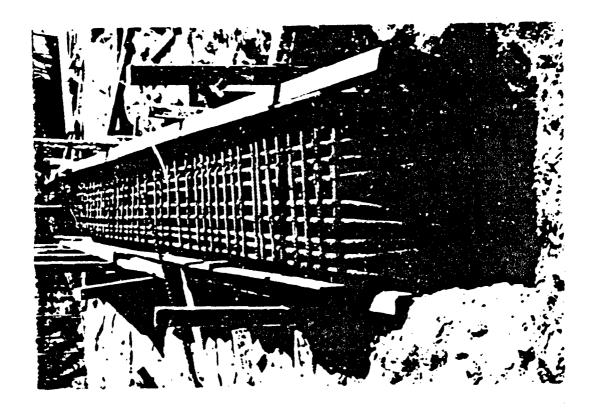
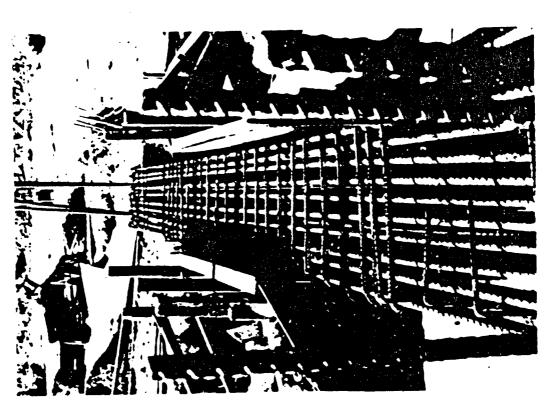
FIGURE 31 -- Hospital Construction -- Beam Reinforcing Steel

Two construction related problems occurred but both were easily resolved. The first problem involved the fact that the shop drawings for the reinforcing steel were completed after the major steel order had been placed. Rather than risk a possible construction delay awaiting the specialized reinforcing steel, the decision was made to redesign the shop drawings to use commonly available steel. A second problem occurred when a concrete tooting was poured from non-shelter construction documents which left the footing one foot higher than it should have been. The resolution was a redesign of the detail to accept a beam above the new footing (see Figure 32). No other significant problems were encountered during the construction. There was difficulty with ground water in an area proximal to the shelter footings, but this was not attributable to the shelter design.

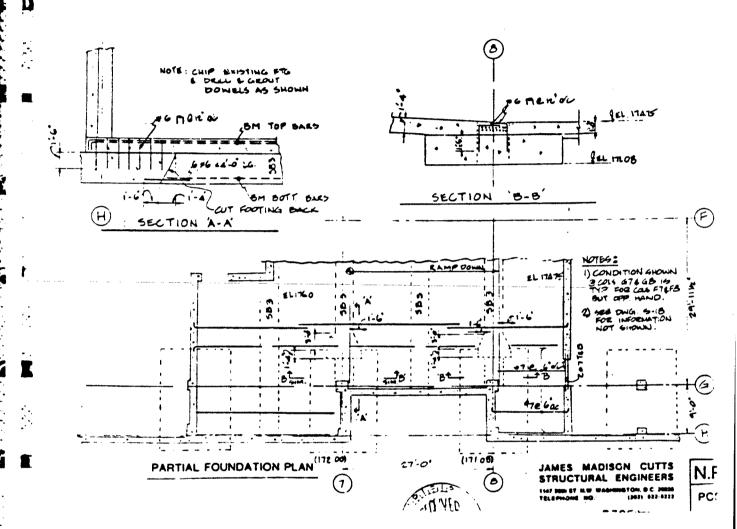
FIGURE 32 -- Beam/Footing Connection Details

- o Construction difficulties exist with wall penetrations and beam corners which do not fit flush with other building elements.
- o The scheduling of concrete pours requires careful planning and special attention.
- o Careful planning and additional time is required for building up reinforcing steel during shelter construction.
- o Blast shelter construction did not constitute an extraordinary problem. It was rather one more layer of complexity to be coordinated into the overall process.

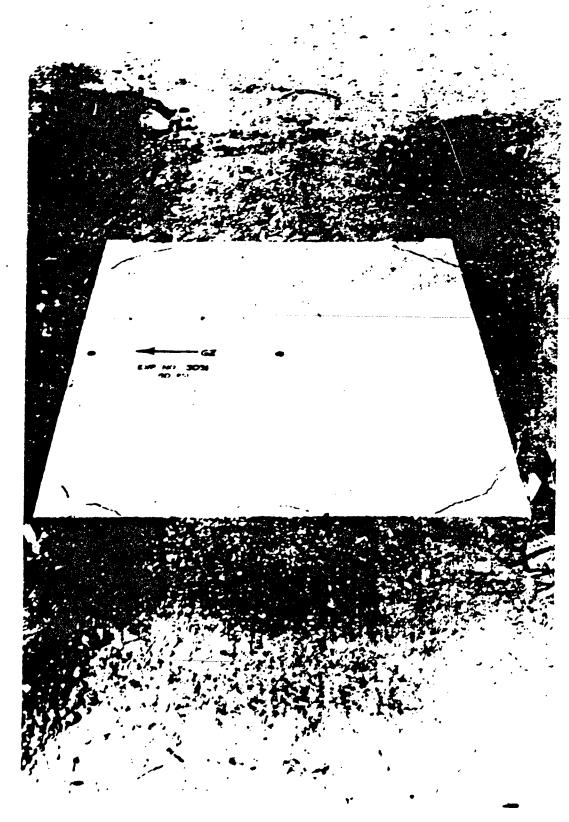
FIGURE 44 -- Post-Blast View of Hospital Shelter at 50 psi Level -- Showing Hairline Cracks on Roof

The model exposed to 15 psi overpressure suffered no apparent structural damage (see Figure 43). The model exposed to 50 psi overpressure suffered only minor damage in the form of hairline cracks. The cracks may be seen on the photographs (see Figures 44-45). The cracks were traced with a marker to highlight their location, but the result is that the damage appears more serious than actual. The apparent conclusion is that the design guidance provided by "Protective Construction", TR 20, (Vol.4) leads to partial overdesign for shelter structures intended to withstand 15 psi overpressure.
